## PROCESS

**Service Provided:**  
Tire Grinding & Laser Alignment

**Industry:**  
Mining

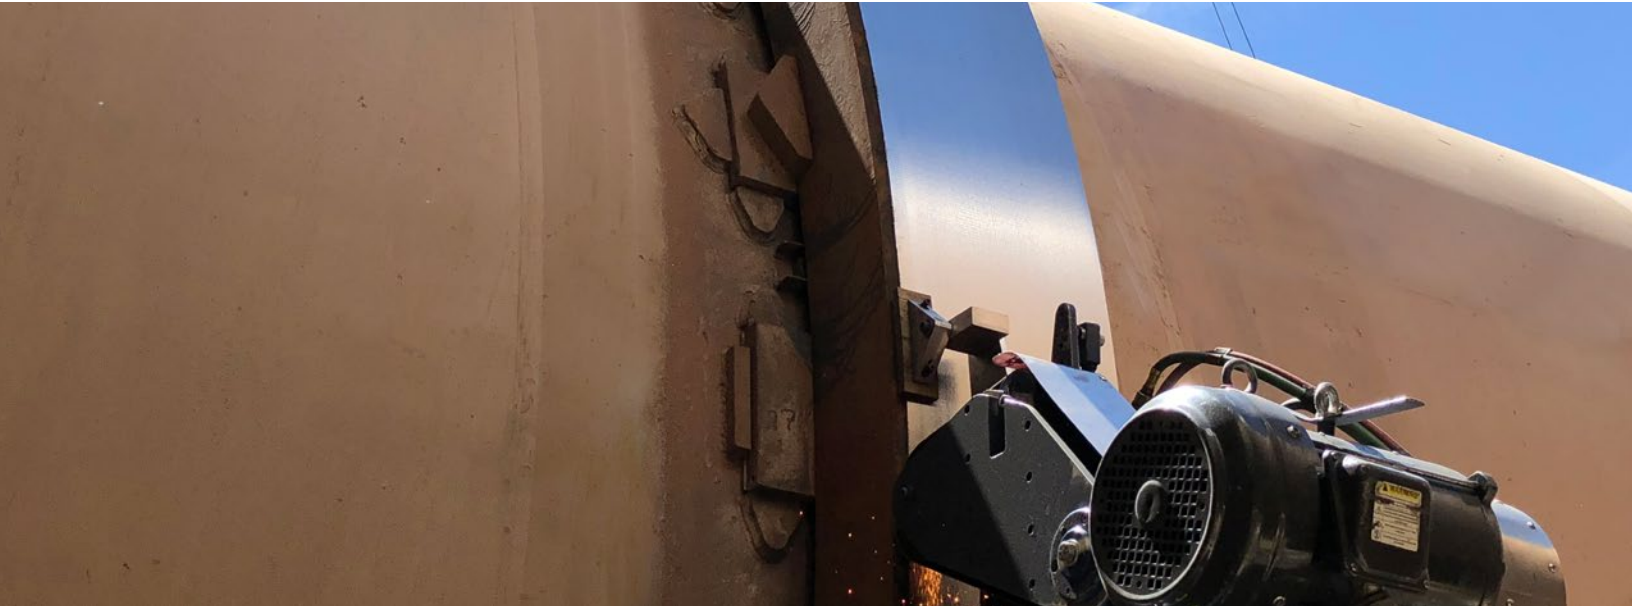
The site's Mechanical Planner contacted FEECO after being unhappy with their existing service provider. Some of the 12 on-site agglomerators were exhibiting severe tire wear and needed attention.

FEECO Customer Service Engineers visited the site, assessed the issues, and corrected the problem through [tire and trunnion grinding](#). Because grinding makes adjustments to the mechanical structure of the unit, FEECO followed the grinding with a [laser alignment](#) of each affected unit. Post-maintenance alignment ensures that the unit is mechanically stable and minimizes wear on tires and trunnions going forward. If an alignment were not carried out, wear would resume.
